FIGURE 1 SCANNER SYSTEM BLOCK DIAGRAM.

FIGURE 2. LAYOUT, SEARCH AND RESCUE SCANNER 2 AXIS STABILIZED OPTICAL HEAD

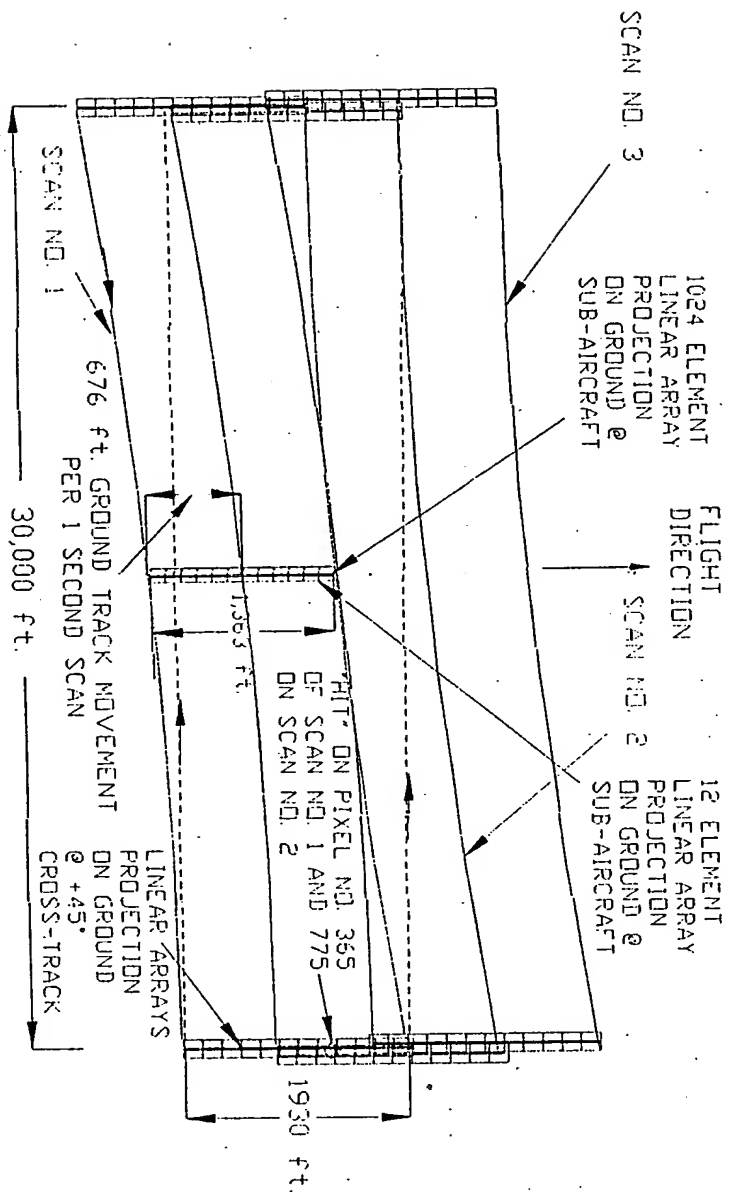
NOTES: 1. ALL DIMENSIONS ARE IN FEET ON
LEVEL GROUND FOR 10,000 FT.
AIRCRAFT ALTITUDE
2. SCAN PATHS ARE SHOWN WITH EXAGGERATED
STABLE PLATFORM ROLL OSCILLATION FOR EASE OF PRESENTATION

FIGURE 3 - PROJECTION OF CROSS-TRACK SCAN ON LEVEL GROUND FOR
1,860 FT. SCANNER ALTITUDE (NO DETECTION FOLDOVER CORRECTION)

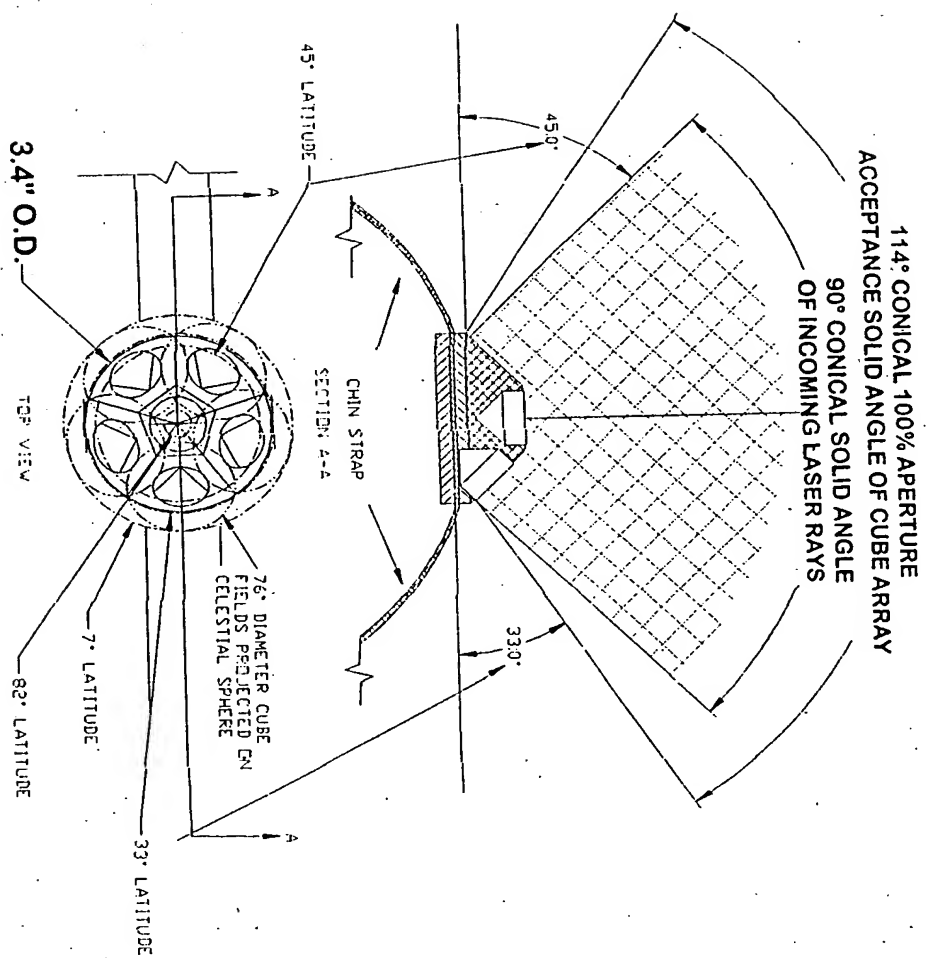
FIGURE 4 LAYOUT OF HEAD-MOUNTED CORNER CUBE ASSEMBLY

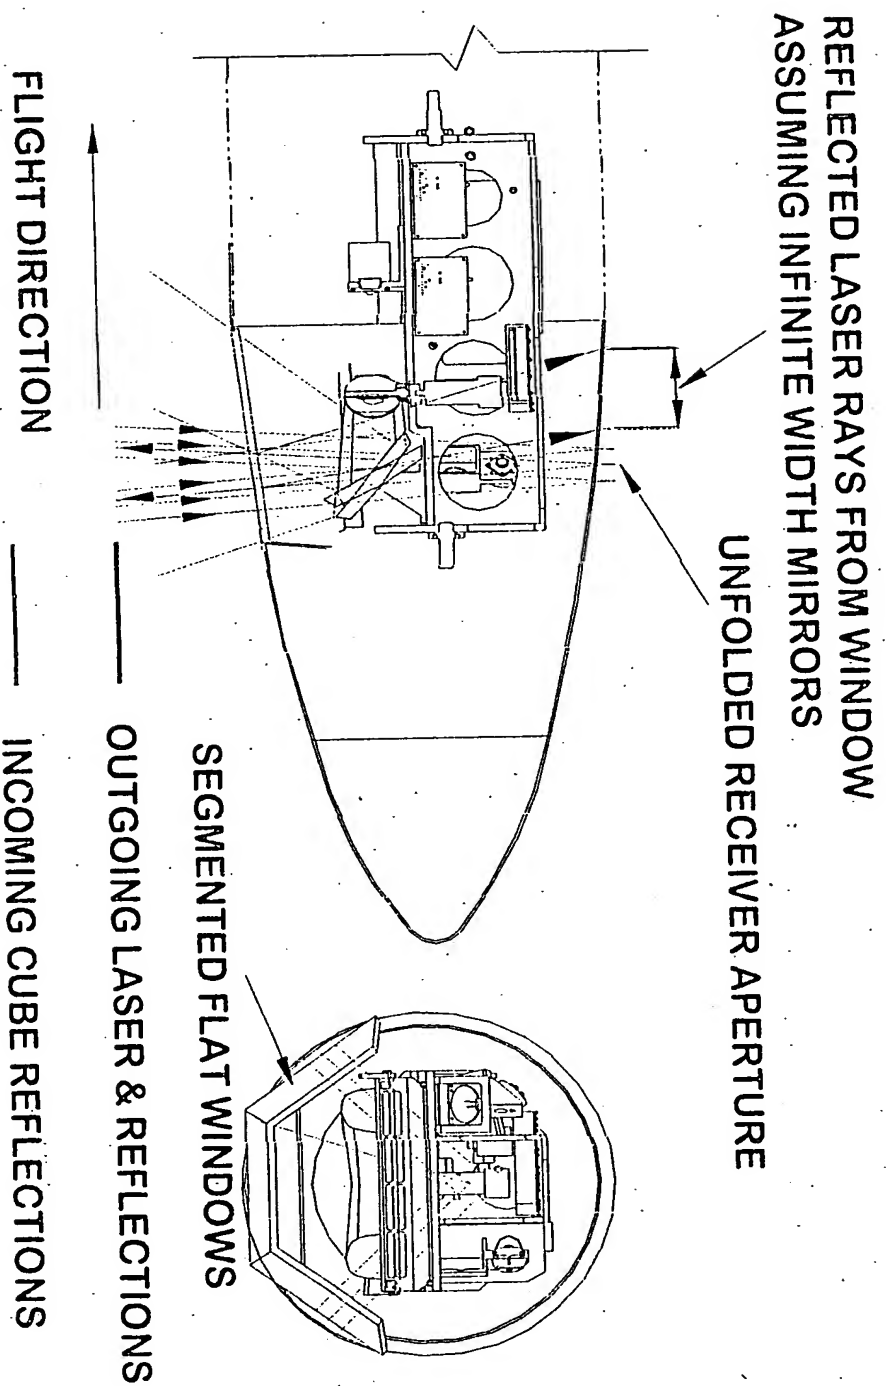
FIGURE 5 OPTICAL HEAD LAYOUT MOUNTED IN F-16 TRAVEL POD SHOWING WINDOW REFLECTIONS ARE NOT SEEN BY RECEIVERS

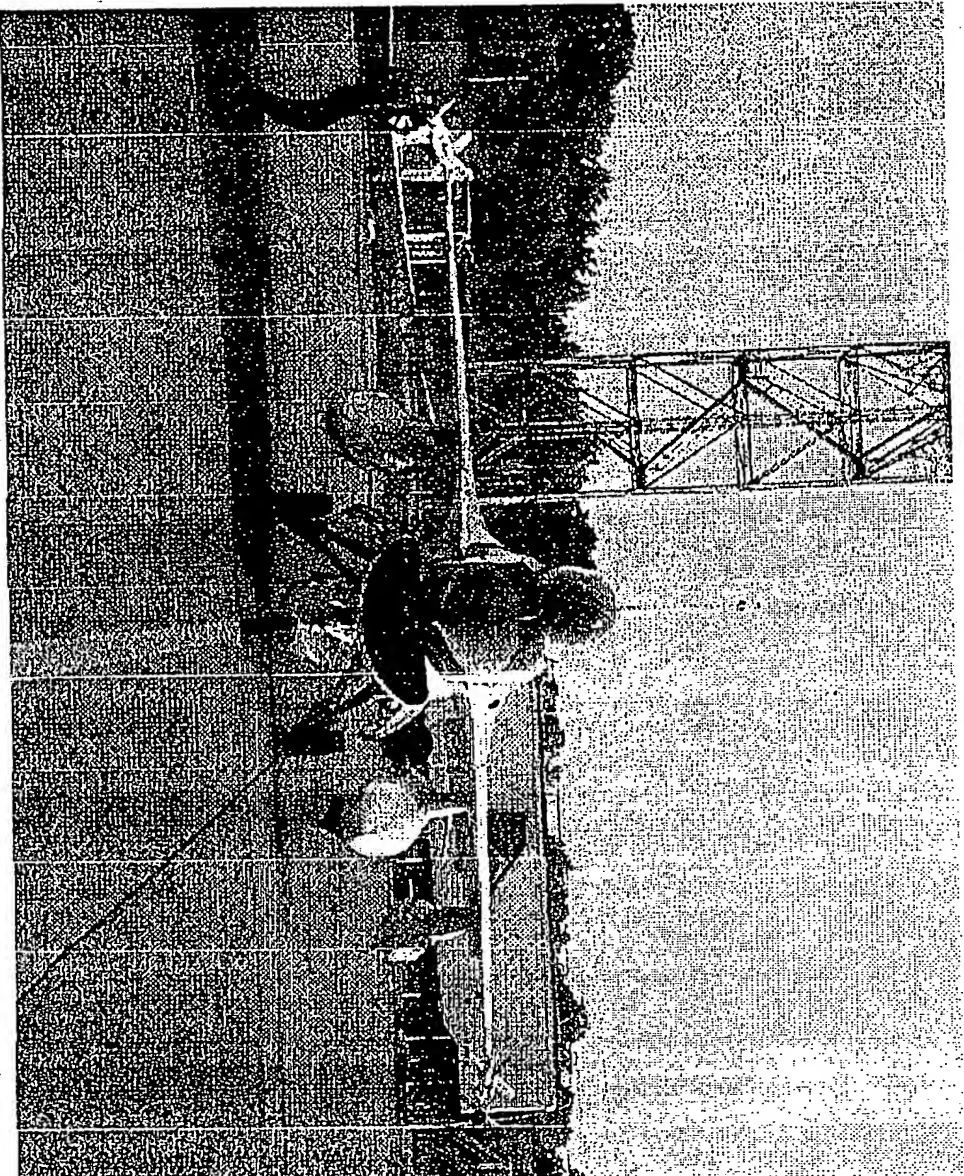
FIGURE 6 F-16 WITH LUGGAGE POD FOR SCANNER, SHOWN (RIGHTMOST)

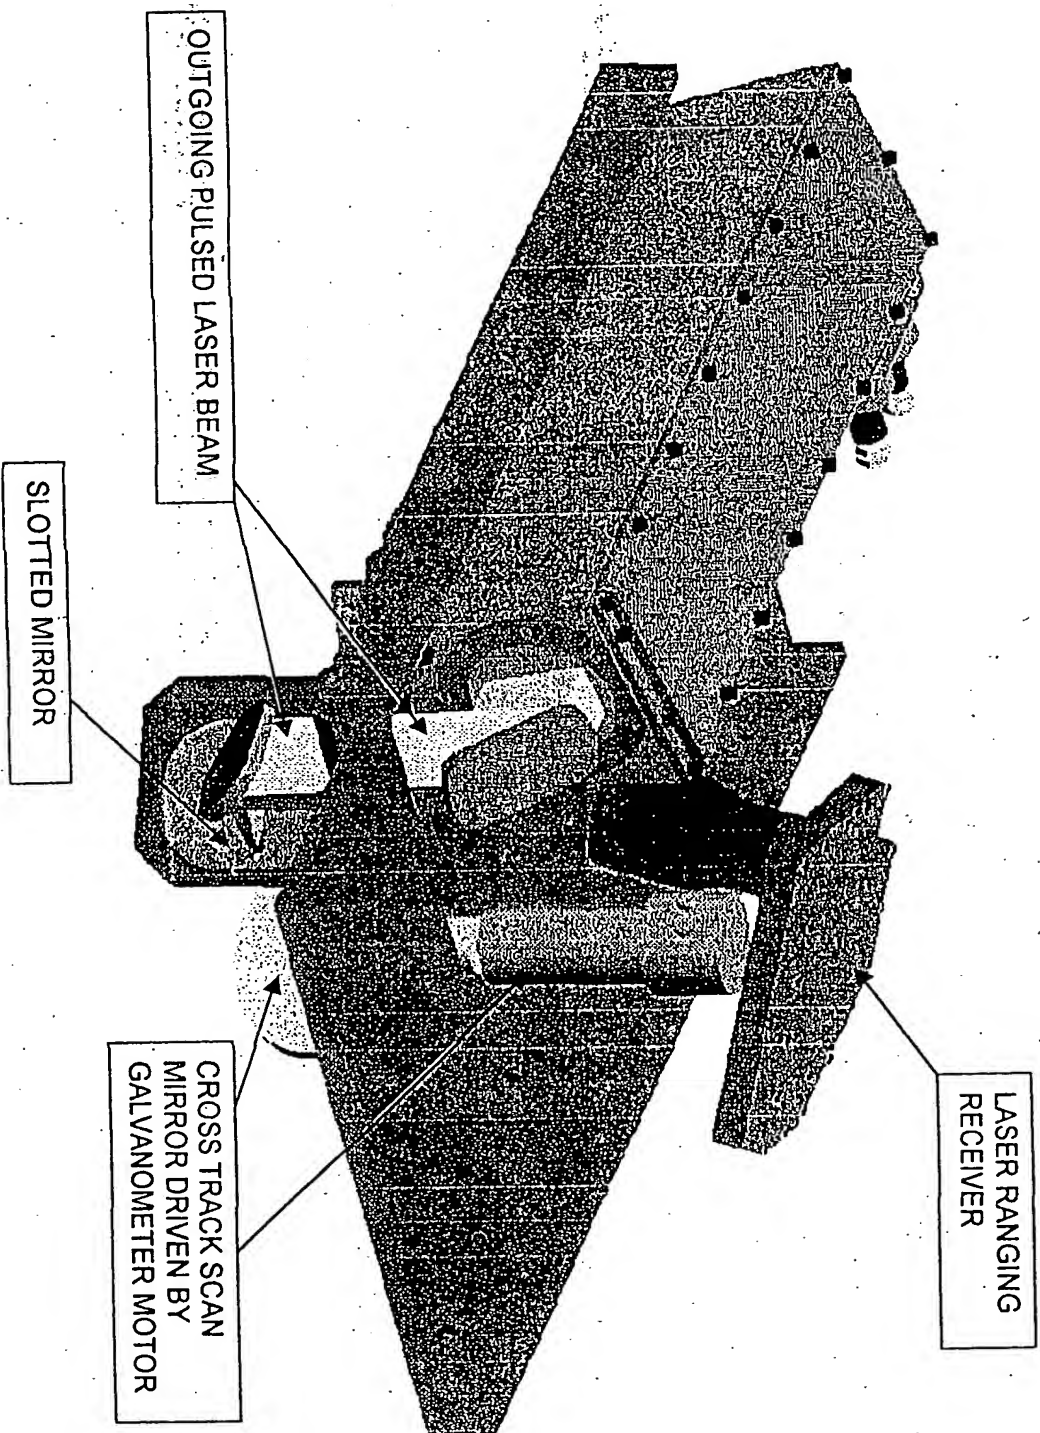
FIGURE 7 LASER RAY PATHS IN SCANNER (PITCH STABILIZATION MIRROR NOT SHOWN)

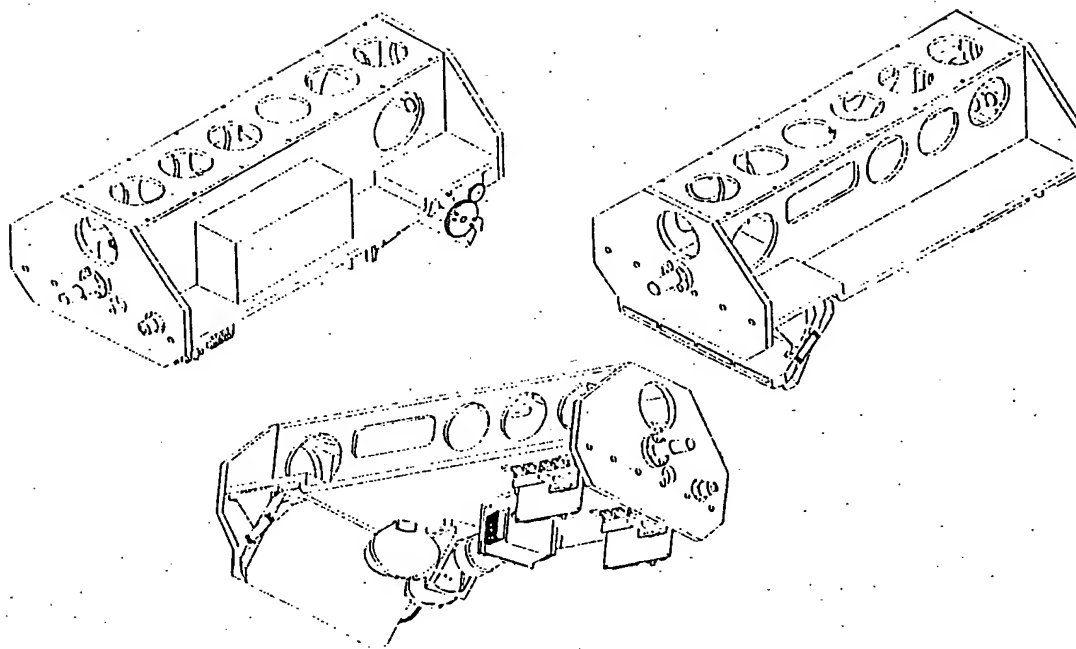
FIGURE 9 COMBAT SEARCH AND RESCUE SCANNER MODIFIED INTO IRST SCANNER
